## Final Project Report

### FIELD AND DATA MAINTENANCE OF THE FL-DEP BoMR VEGETATIVE FILTER STRIP RESEARCH FACILITY IN HOMELAND, BARTOW (FL)

**Sponsoring Agency:**  
The Florida Department of Environmental Protection  
Bureau of Mine Reclamation  
DEP Order No. 798181

**June 2008**

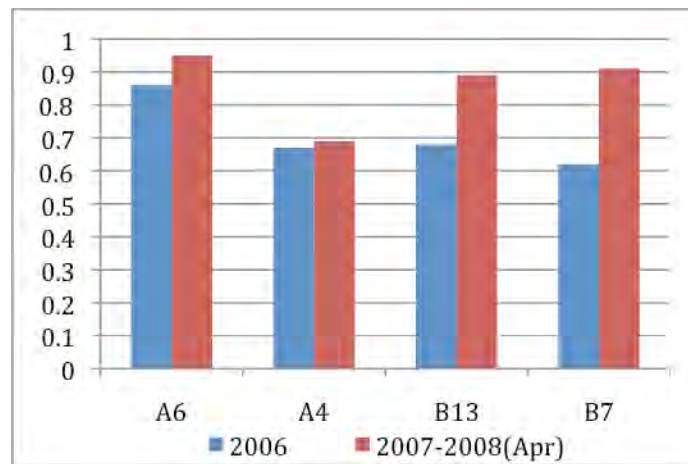
**Figure 3. Flow volume removal efficiency of VFS during the period 2006 – 2008 (April)**

For Site A (River) the filter efficiencies obtained in this report closely match and confirm those obtained in the previous 2006 study (Muñoz-Carpena et al., 2007). VFS runoff volume reduction efficiencies reported for plots A6 and A4 were similar, 0.86 and 0.67 respectively (Fig. 3). Sediment and TP removal for both studies were also close, above 0.9 (Fig. 4 and 5), and DP removal efficiencies were also lower than 0.70 in both studies although somewhat lower for plot A6 (Fig. 6). In general, filter length in general shows a clear trend in terms of reduction of runoff volume. This is clearly seen in Site A (Fig.3), with increased efficiencies for the longer filters.

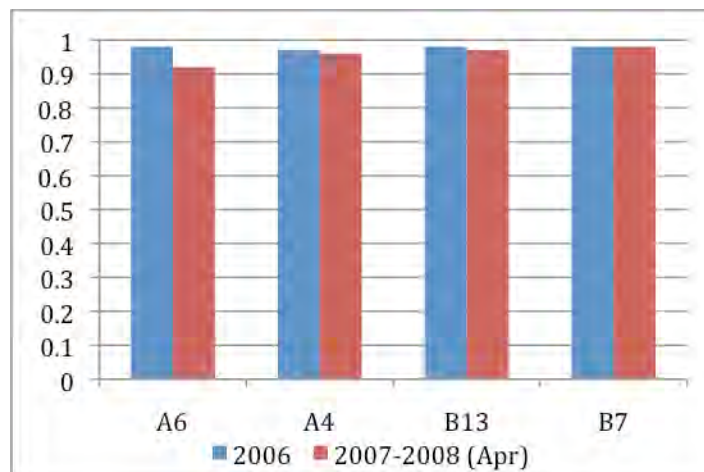
**Figure 4. Sediment removal efficiency of VFS during the period 2006 – 2008 (April).**

Results for the Hill B (River) were also similar between the two studies in terms of filter reduction of particulates (sediment and TP) (Fig. 4 and 5). Dissolved phosphorus was found different at this site (Fig. 6), especially at B13. This large difference is likely related to the data gaps for these plots due to maintenance and equipment malfunction. It is expected that the data collected through the end of summer 2008 (rainy period) will match the trends observed in the previous study.
