Final Project Report

FIELD AND DATA MAINTENANCE OF THE FL-DEP BoMR VEGETATIVE FILTER STRIP RESEARCH FACILITY IN HOMELAND, BARTOW (FL)

Sponsoring Agency:
The Florida Department of Environmental Protection
Bureau of Mine Reclamation
DEP Order No. 798181

June 2008

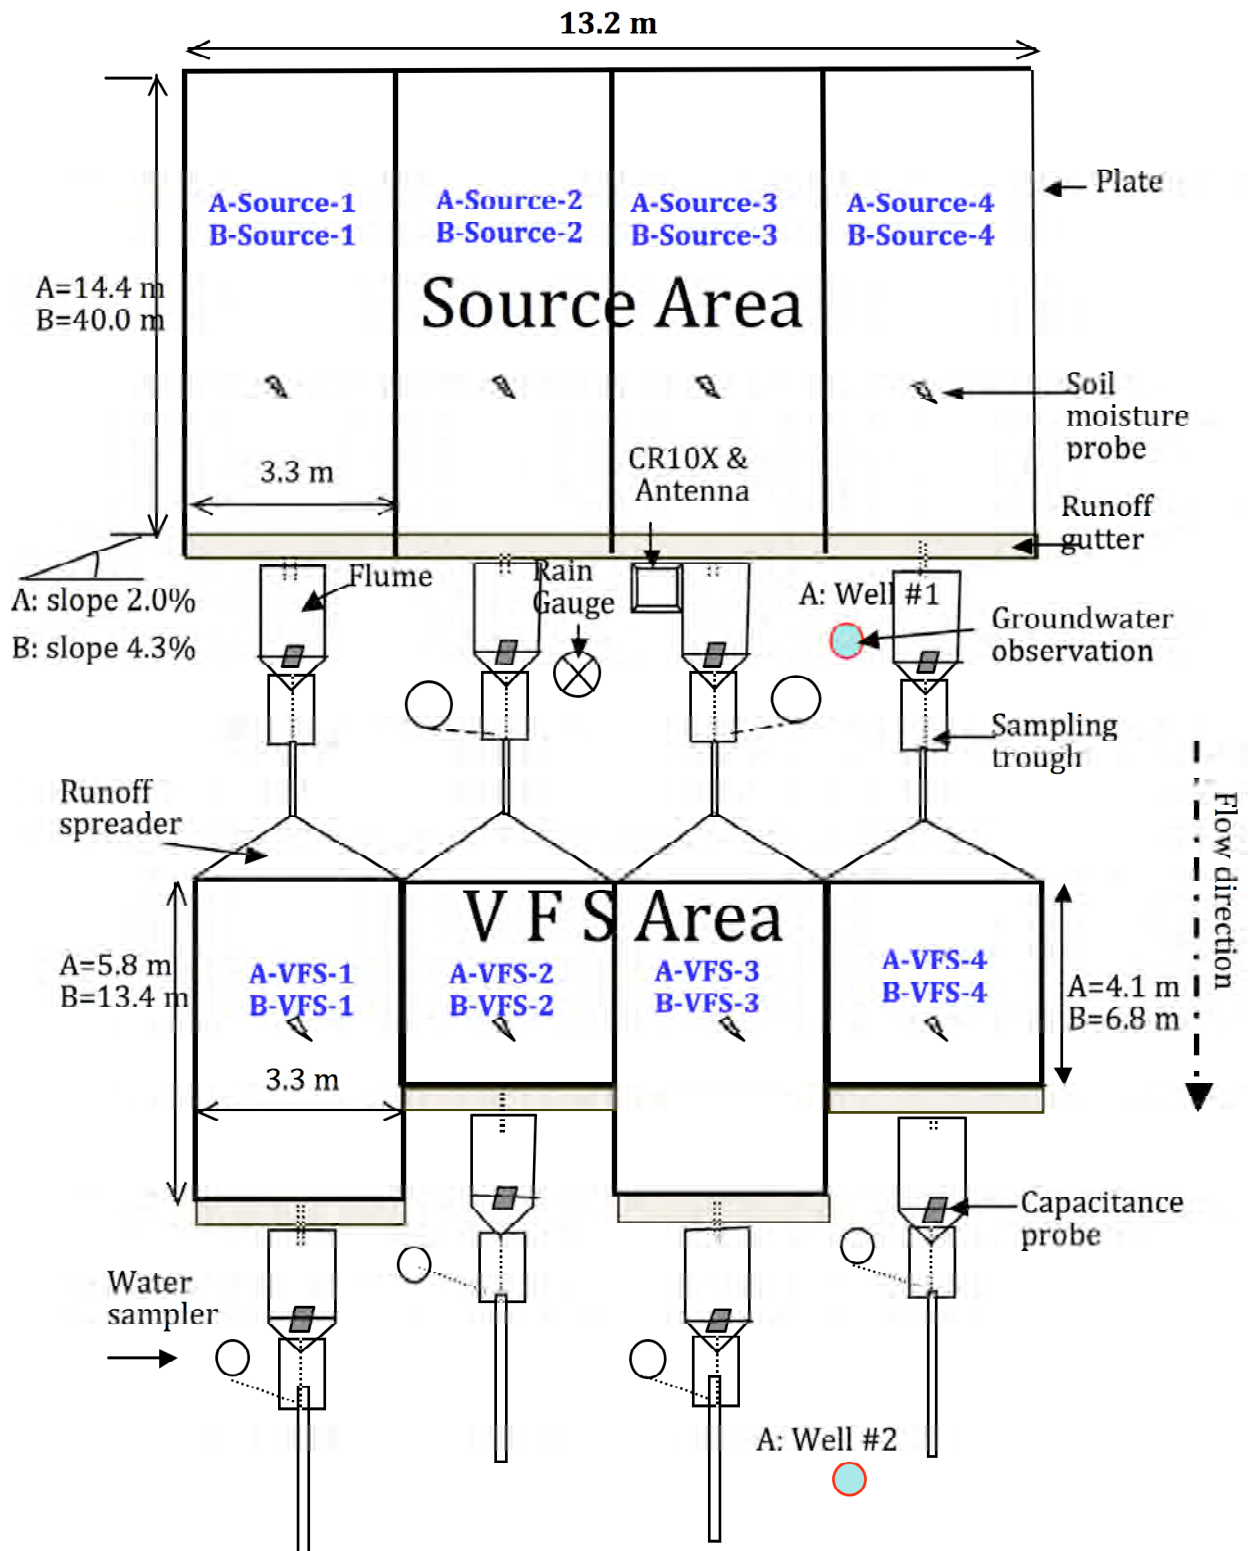
Figure 1. Schematic diagram of the experimental sites A (River) and B (Hill) in the Homeland Field Office, FL

To answer these questions, two experimental sites (A and B) containing 16 runoff plots (8 source+8 VFS) were selected and instrumented for this study (Fig. 1).

The sites represent the range of conditions commonly found in source areas (sand tailings) at the region (i.e. slopes of 2-4.5%, slope lengths of 14-40 m, vegetation properties, and soil hydraulic properties). Source areas were maintained bare (no vegetation) to represent the

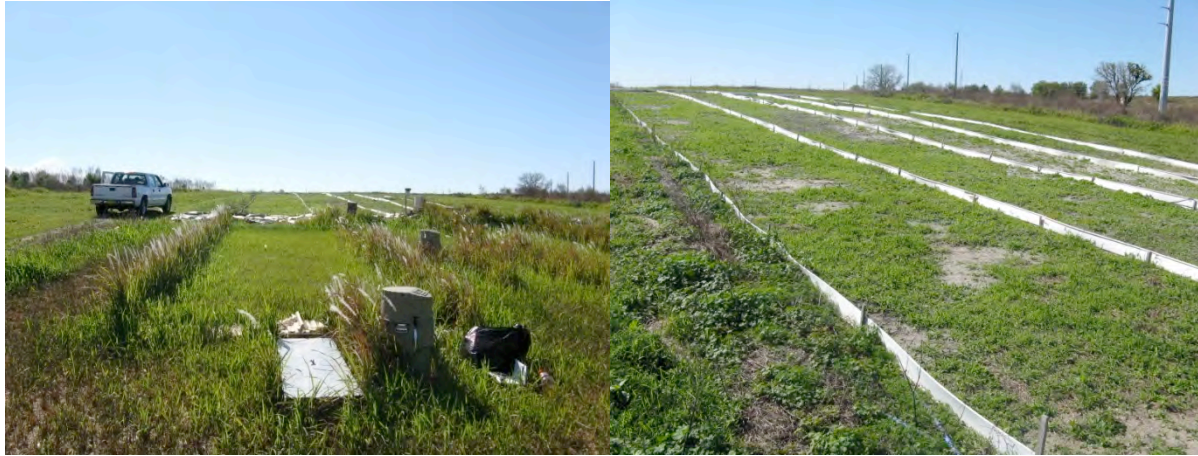
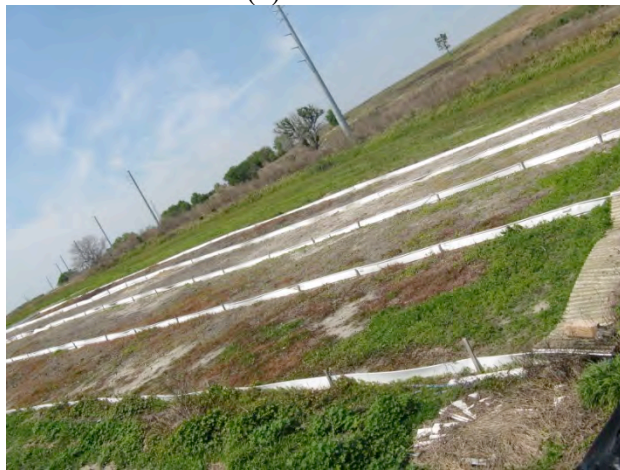
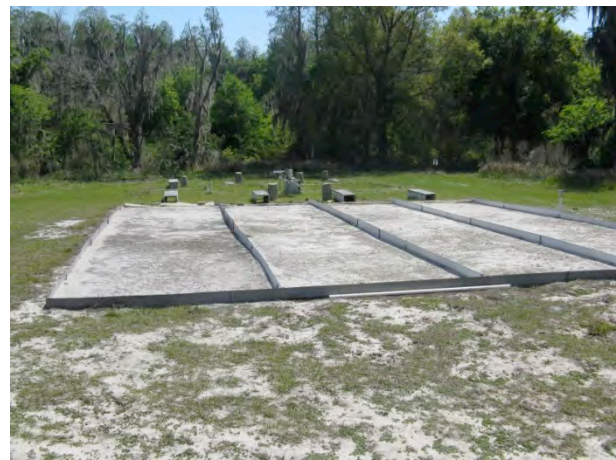
Figure 2. (a) & (b) Source area and VFS at hill on Feb 28 (2008), (c) Source area on March 13 (2008) at the Hill Site, and (d) source area at the River Site at any time of the year.

To ensure the worst-case scenario conditions the source areas were designed to be maintained bare (no vegetation at all times). Figure 2 shows the fast growth of weeds experienced at the Hill site. For instance, Hand removal of weeds and spot application of contact herbicide was done during the last week of January (2008). After a month, the source areas were completely covered again (Fig. 2a and 2b). Additional weed control took place the first week of March. By the second week of March the weeds were controlled, except for a small spot at the end of the source areas (Figure 2c). In contrast, Figure 2d shows that the source area on the River Site remained clean during all the year after receiving the same maintenance as in the Hill site.

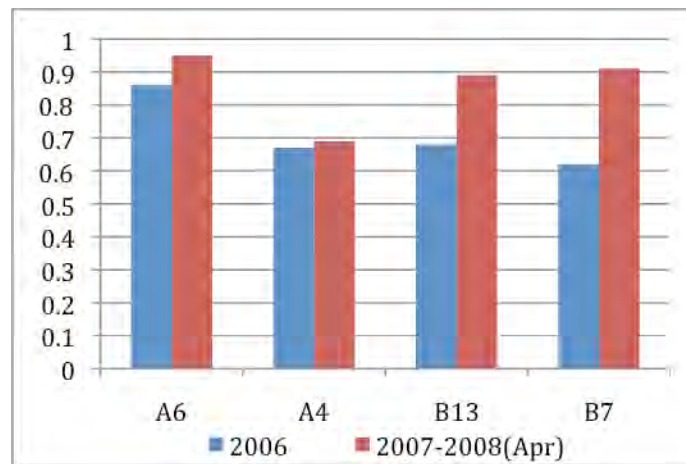
Figure 3. Flow volume removal efficiency of VFS during the period 2006 – 2008 (April)

For Site A (River) the filter efficiencies obtained in this report closely match and confirm those obtained in the previous 2006 study (Muñoz-Carpena et al., 2007). VFS runoff volume reduction efficiencies reported for plots A6 and A4 were similar, 0.86 and 0.67 respectively (Fig. 3). Sediment and TP removal for both studies were also close, above 0.9 (Fig. 4 and 5), and DP removal efficiencies were also lower than 0.70 in both studies although somewhat lower for plot A6 (Fig. 6). In general, filter length in general shows a clear trend in terms of reduction of runoff volume. This is clearly seen in Site A (Fig.3), with increased efficiencies for the longer filters.

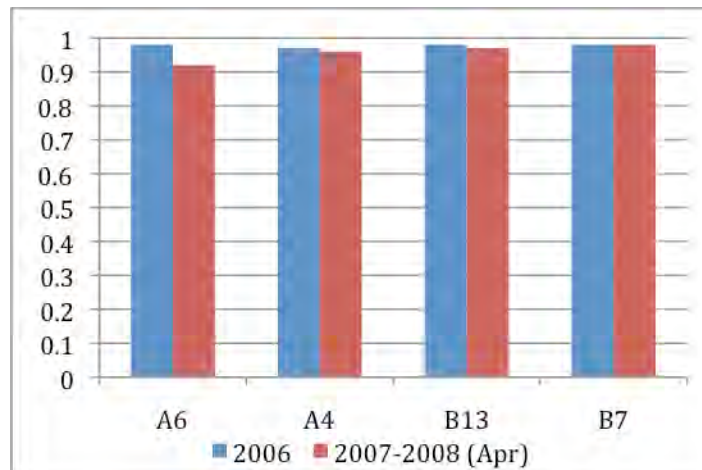
Figure 4. Sediment removal efficiency of VFS during the period 2006 – 2008 (April).

Results for the Hill B (River) were also similar between the two studies in terms of filter reduction of particulates (sediment and TP) (Fig. 4 and 5). Dissolved phosphorus was found different at this site (Fig. 6), especially at B13. This large difference is likely related to the data gaps for these plots due to maintenance and equipment malfunction. It is expected that the data collected through the end of summer 2008 (rainy period) will match the trends observed in the previous study.

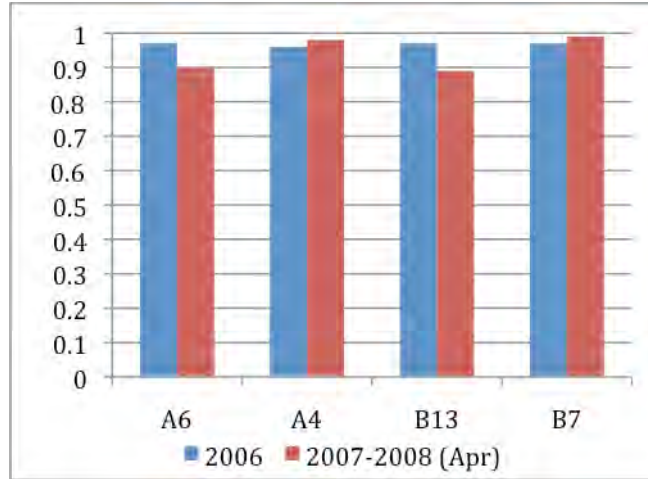
Figure 5. Total Phosphorus removal efficiency of VFS during the period 2006 – 2008 (April).

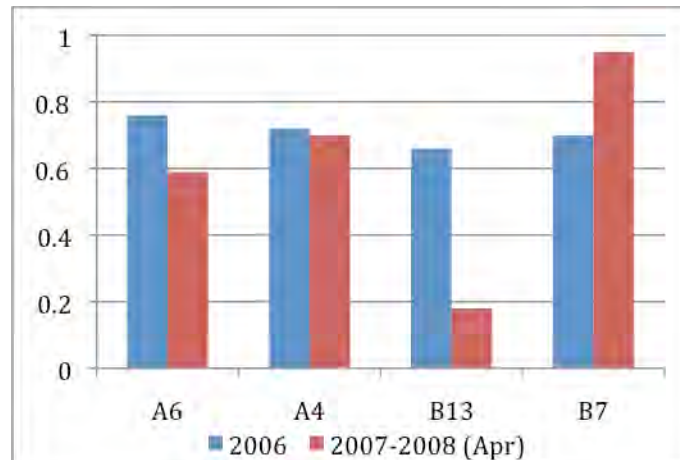
Figure 6. Dissolved Phosphorus removal efficiency of VFS during the period 2006 – 2008 (April).
