# Irrigation Efficiency Research Update

Tampa Bay Water  
Conservation Coordination Committee  
May 14, 2014  
Clearwater, FL

Michael D. Dukes, PhD., P.E., C.I.D.

Agricultural & Biological Engineering  
University of Florida/IFAS

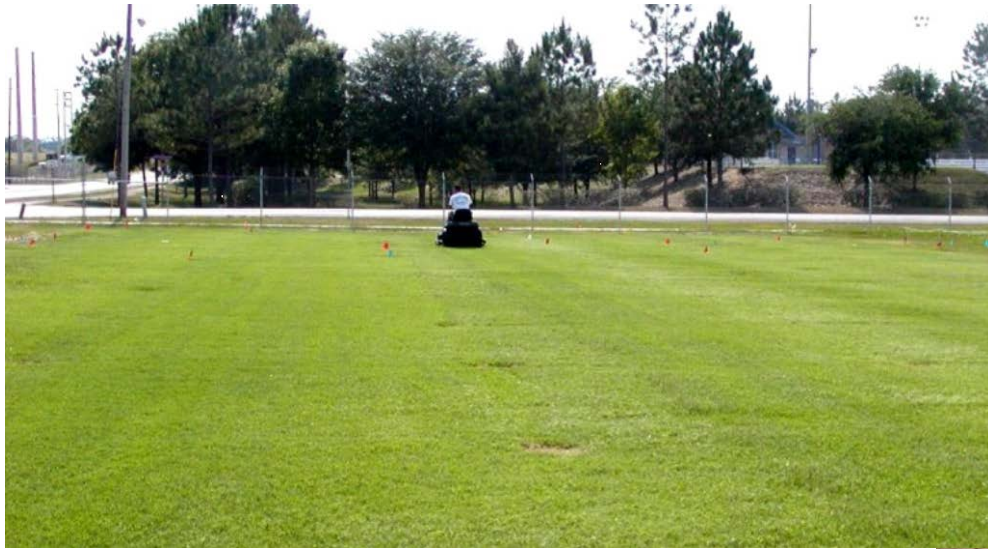
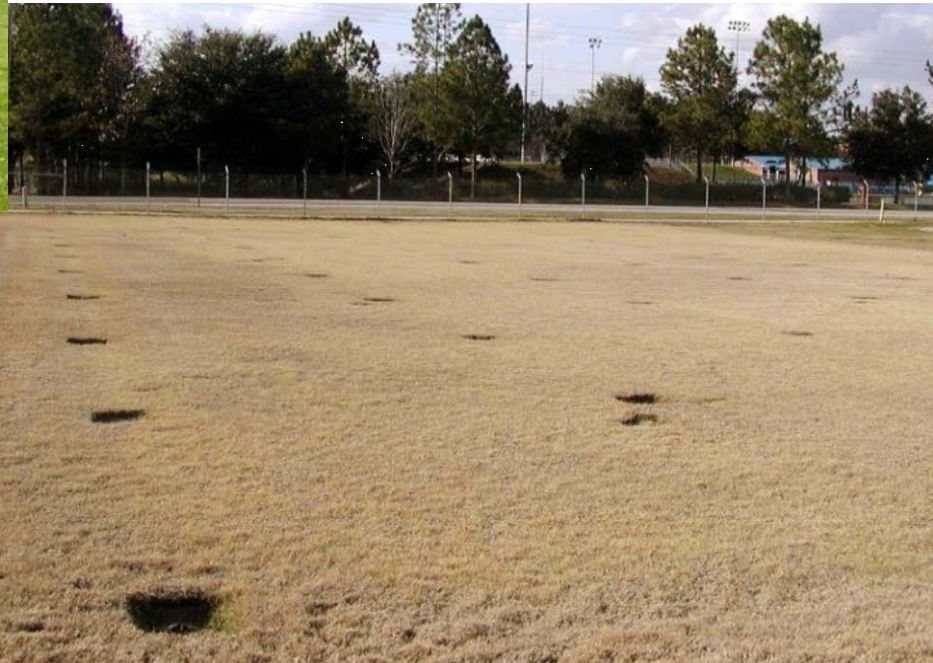
# Gainesville Plots

- May 2004 – Oct 2007
- Plot testing, Gainesville, bermudagrass
- 4 SMS brands
- 1, 2, 7 d/wk frequency

- SMS
  - ~70% savings during normal-wet rainfall
  - ~50% savings during dry conditions
- Savings while maintaining turf quality

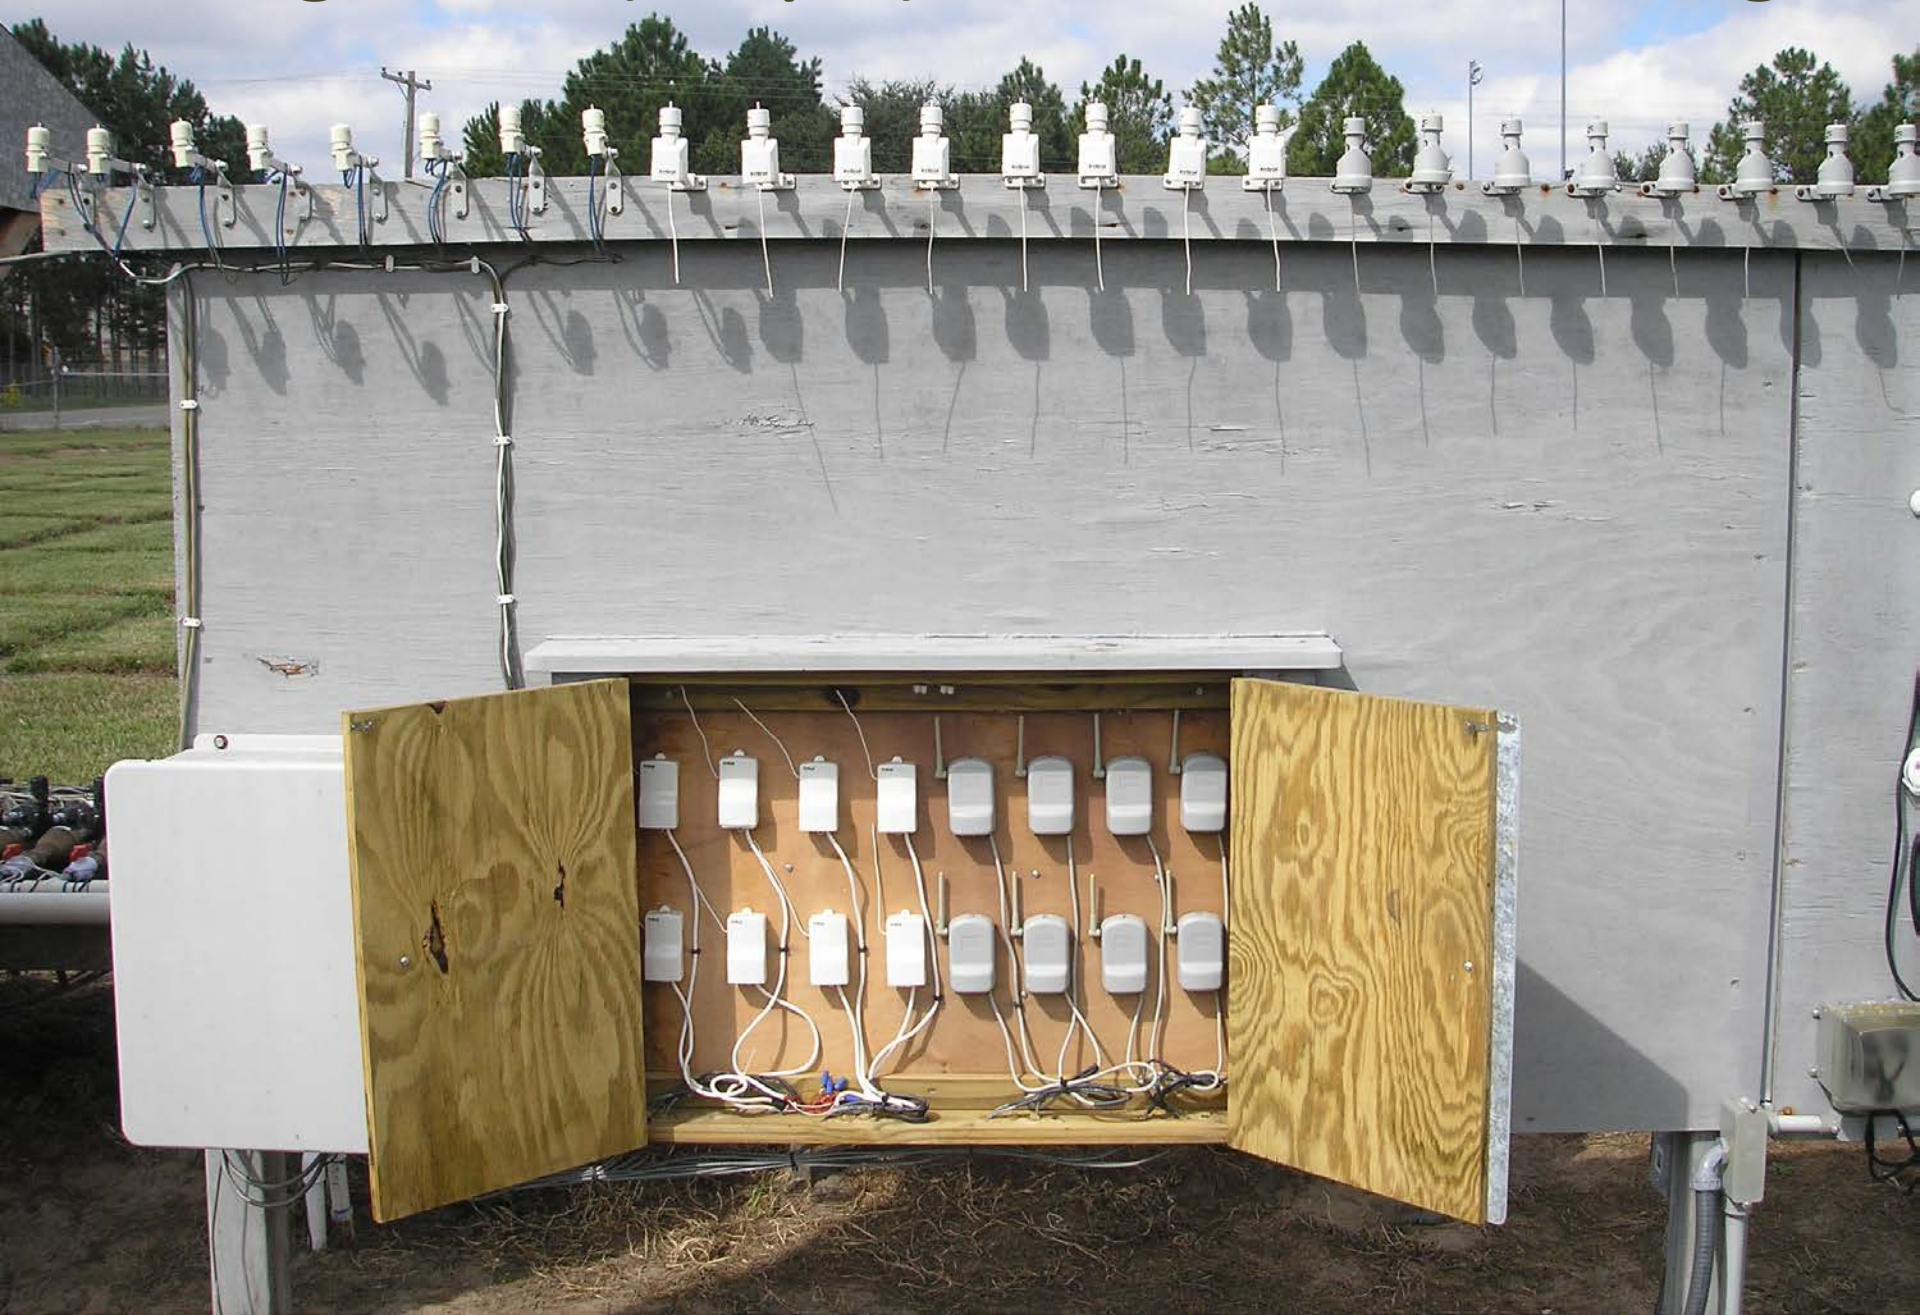
# Long Term (3+ yrs) Rain Sensor Testing

- Most are 50% - 70% accurate
- Ex. 0.25" set point triggers at 0.08 to 0.16"
- Accuracy changes -23% to 25% over 3 years
- Annual maint. required for best performance

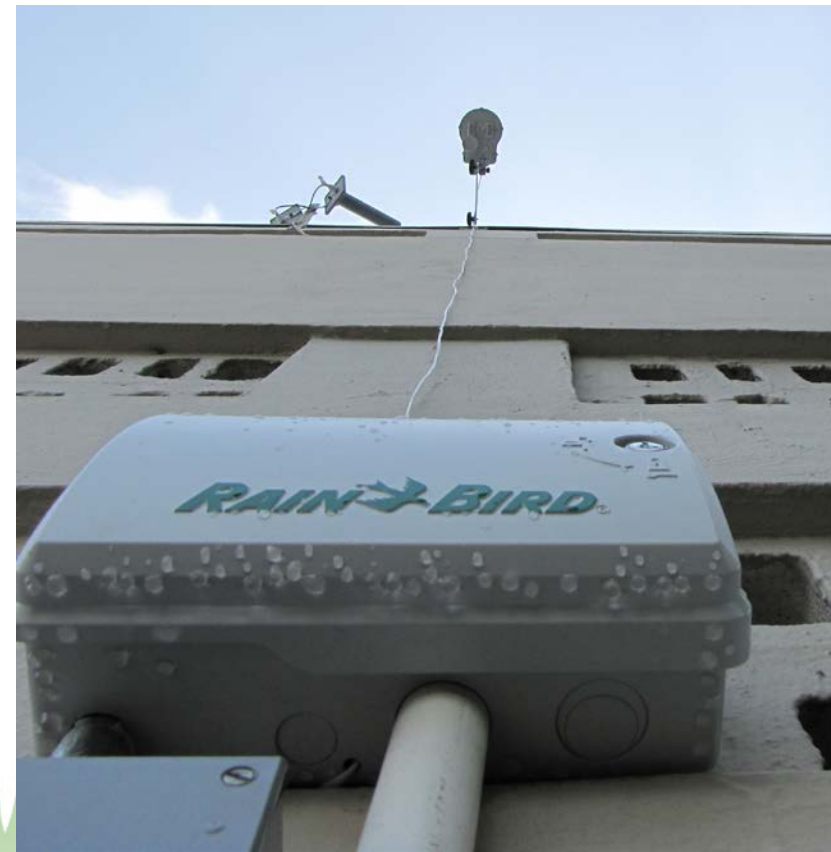
# ET Controllers

- Some can determine runtimes and days
- Programming is key!
  - Soil type
  - Plant type
  - Microclimate
  - Application rates
  - Slope

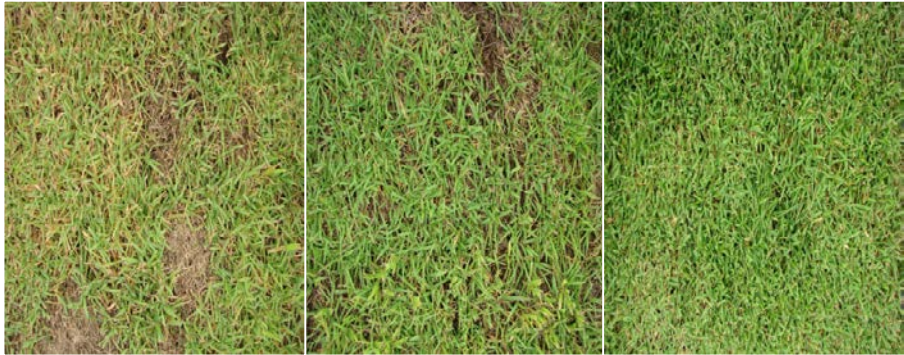
Empire Zoysiagrass

Quality Rating 3

Quality Rating 5

Quality Rating 7

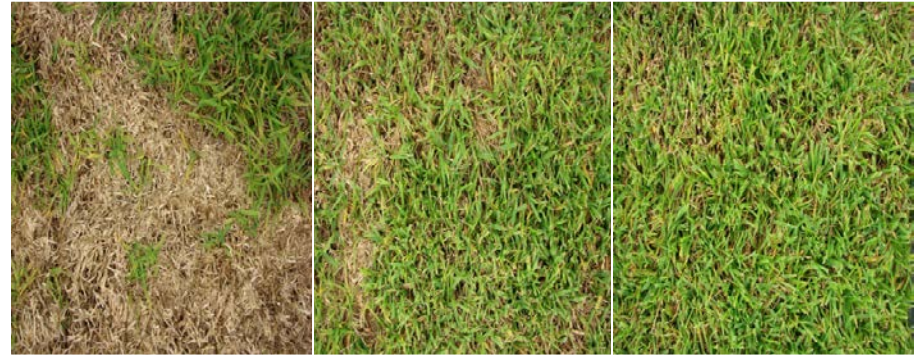
Captiva St. Augustinegrass

Quality Rating 3

Quality Rating 5

Quality Rating 6.5

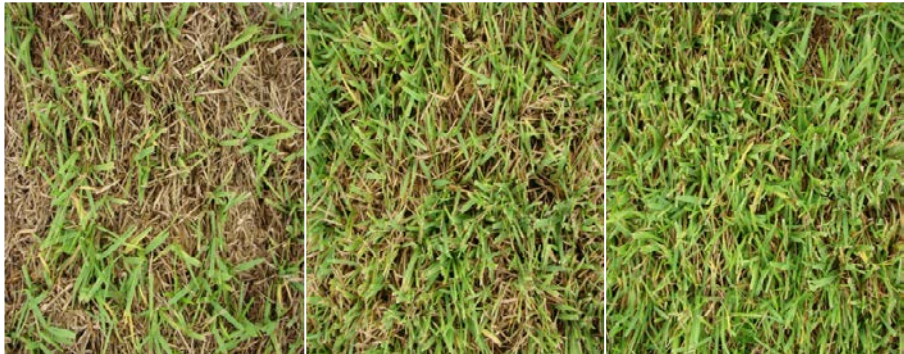
Floritam St. Augustinegrass

Quality Rating 3

Quality Rating 5

Quality Rating 6.5

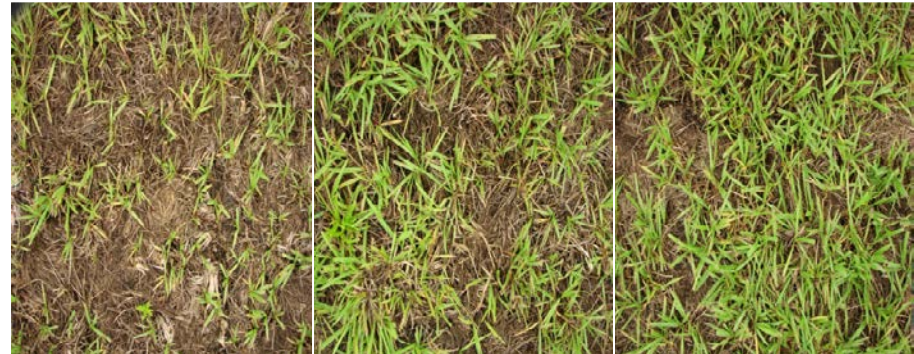
Argentine Bahiagrass

Quality Rating 3

Quality Rating 5

Quality Rating 6.5

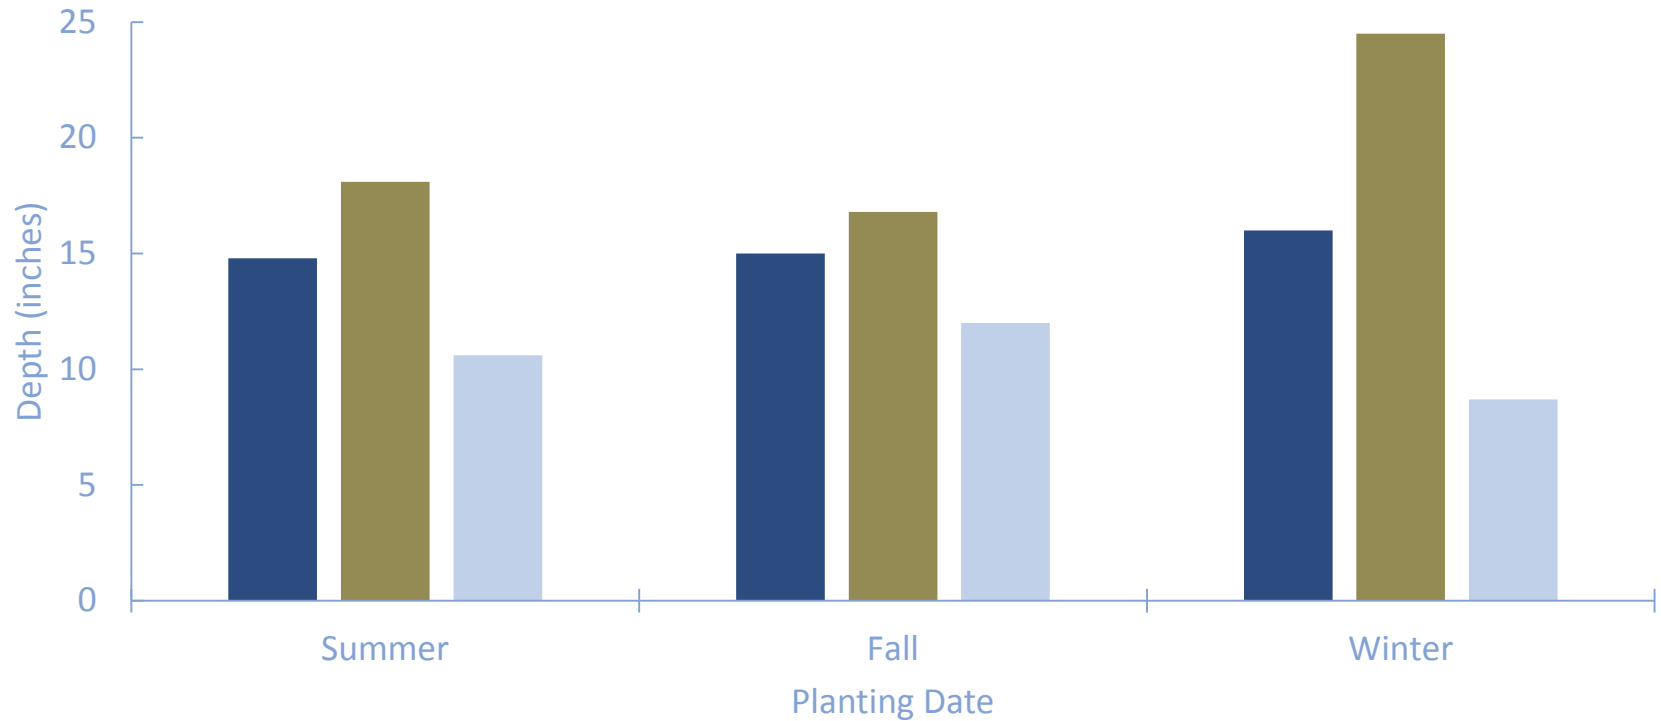
# Year One Irrigation (0-60 d)

■ 15-15 Establishment Irrigation   ■ 30-30 Establishment Irrigation   ■ No Establishment Irrigation

- Bahiagrass – Increasing establishment irrigation did not increase long-term quality
- Captiva St. Augustinegrass – Higher quality on 30-30 or 15-15 in summer
- Floratam St. Augustinegrass – Higher quality on 30-30 or 15-15 in summer
- Empire Zoysiagrass – Highest quality 30-30 first summer
- 15-15 reduced irrigation vs. 30-30 → 26%Summer, 15%Fall, 36%Winter
