## Final Project Report

### FIELD AND DATA MAINTENANCE OF THE FL-DEP BoMR VEGETATIVE FILTER STRIP RESEARCH FACILITY IN HOMELAND, BARTOW (FL)

**Sponsoring Agency:**  
The Florida Department of Environmental Protection  
Bureau of Mine Reclamation  
DEP Order No. 798181

**June 2008**

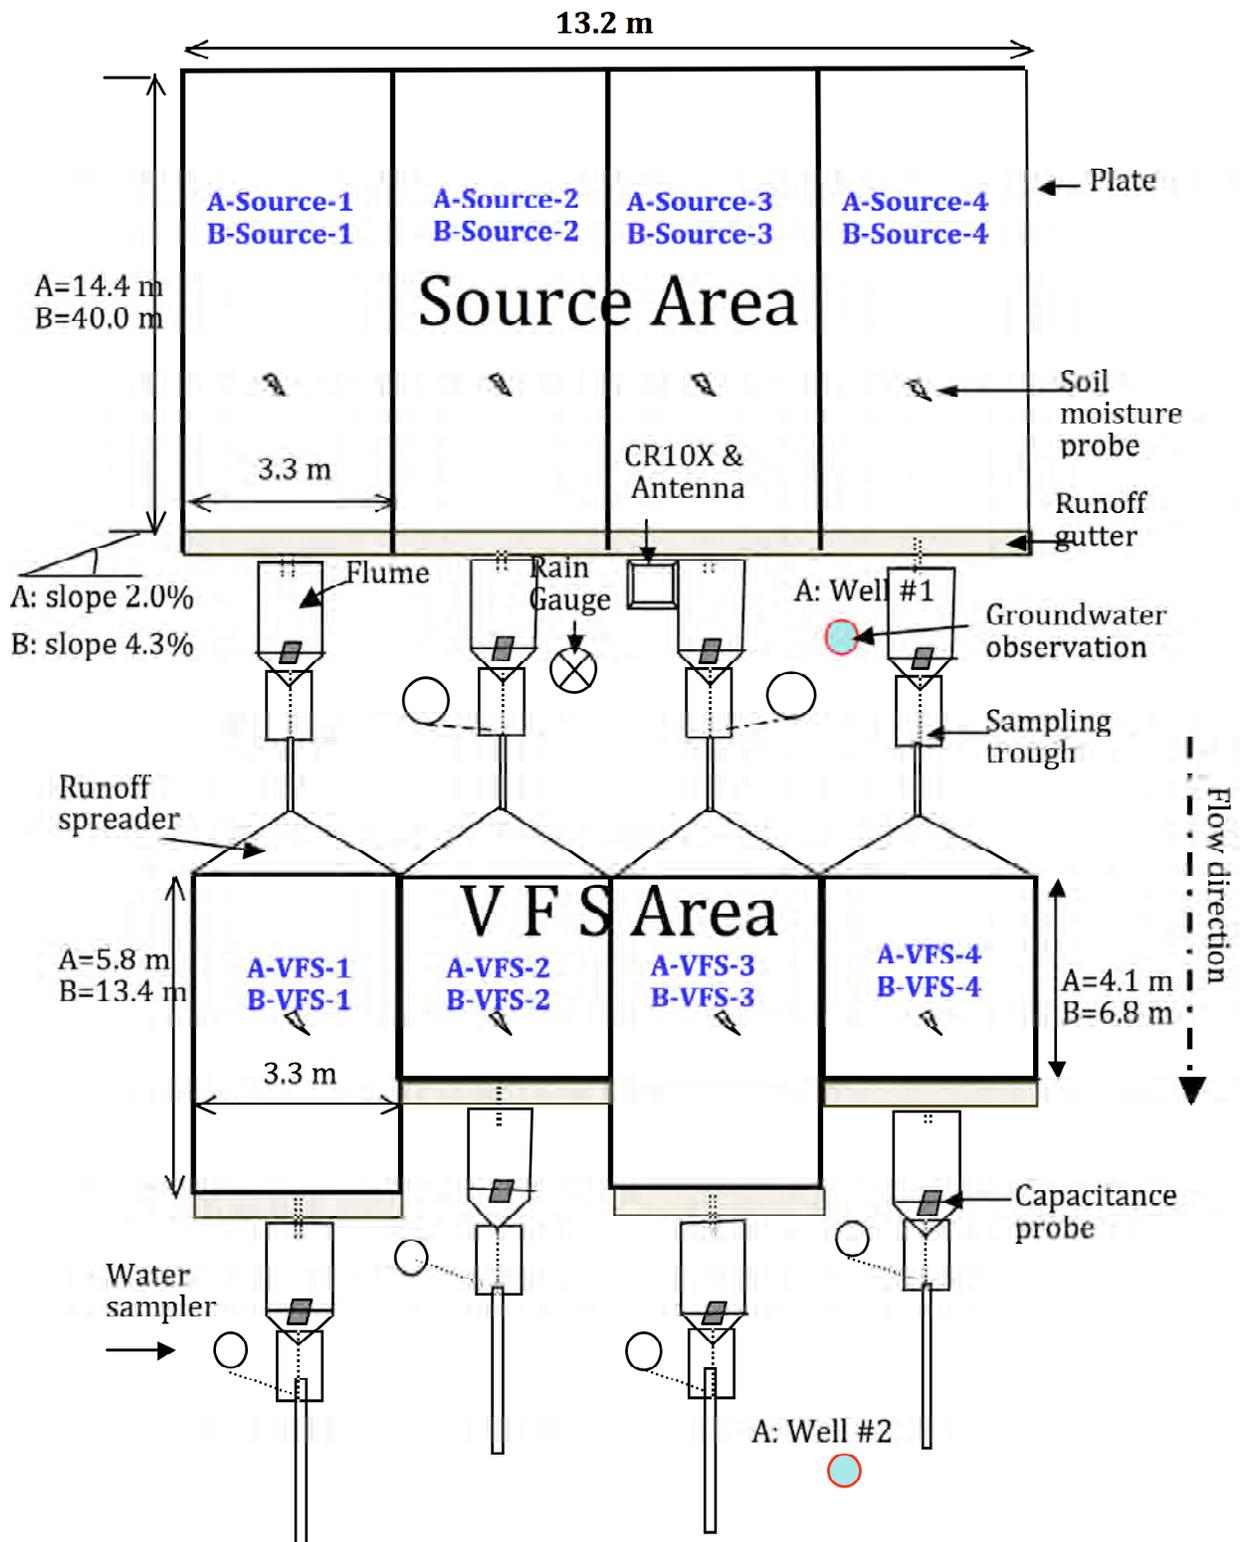
Figure 1. Schematic diagram of the experimental sites A (River) and B (Hill) in the Homeland Field Office, FL

To answer these questions, two experimental sites (A and B) containing 16 runoff plots (8 source+8 VFS) were selected and instrumented for this study (Fig. 1).

The sites represent the range of conditions commonly found in source areas (sand tailings) at the region (i.e. slopes of 2-4.5%, slope lengths of 14-40 m, vegetation properties, and soil hydraulic properties). Source areas were maintained bare (no vegetation) to represent the

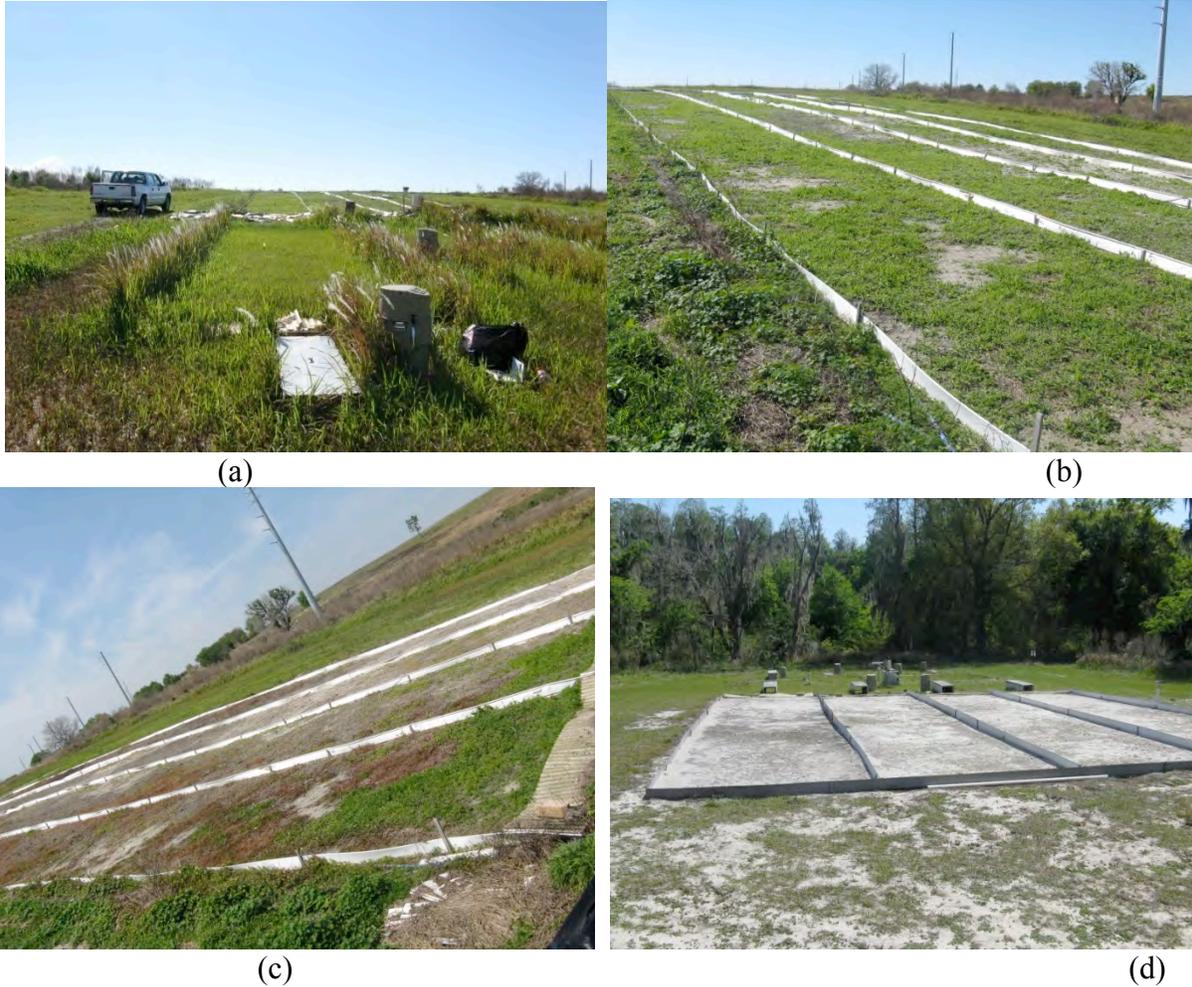
Figure 2. (a) & (b) Source area and VFS at hill on Feb 28 (2008), (c) Source area on March 13 (2008) at the Hill Site, and (d) source area at the River Site at any time of the year.

To ensure the worst-case scenario conditions the source areas were designed to be maintained bare (no vegetation at all times). Figure 2 shows the fast growth of weeds experienced at the Hill site. For instance, Hand removal of weeds and spot application of contact herbicide was done during the last week of January (2008). After a month, the source areas were completely covered again (Fig. 2a and 2b). Additional weed control took place the first week of March. By the second week of March the weeds were controlled, except for a small spot at the end of the source areas (Figure 2c). In contrast, Figure 2d shows that the source area on the River Site remained clean during all the year after receiving the same maintenance as in the Hill site.

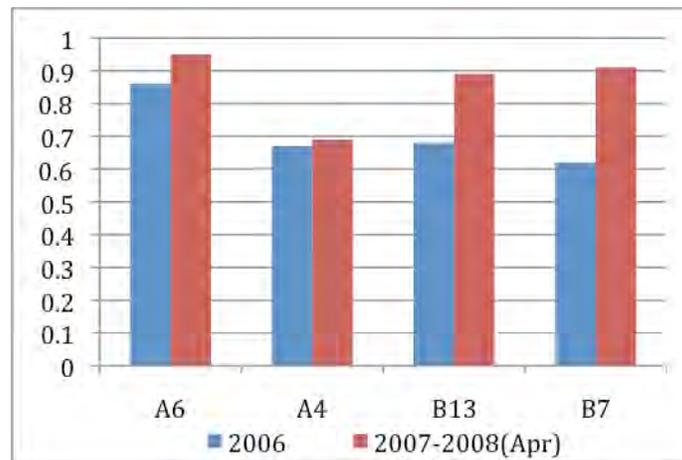
**Figure 3. Flow volume removal efficiency of VFS during the period 2006 – 2008 (April)**

For Site A (River) the filter efficiencies obtained in this report closely match and confirm those obtained in the previous 2006 study (Muñoz-Carpena et al., 2007). VFS runoff volume reduction efficiencies reported for plots A6 and A4 were similar, 0.86 and 0.67 respectively (Fig. 3). Sediment and TP removal for both studies were also close, above 0.9 (Fig. 4 and 5), and DP removal efficiencies were also lower than 0.70 in both studies although somewhat lower for plot A6 (Fig. 6). In general, filter length in general shows a clear trend in terms of reduction of runoff volume. This is clearly seen in Site A (Fig.3), with increased efficiencies for the longer filters.

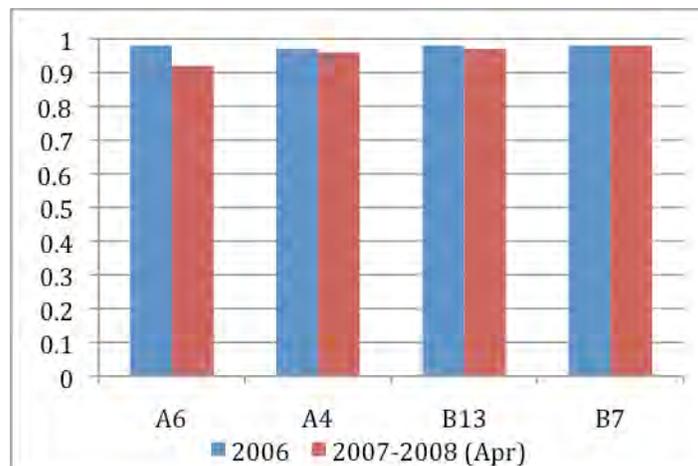
**Figure 4. Sediment removal efficiency of VFS during the period 2006 – 2008 (April).**

Results for the Hill B (River) were also similar between the two studies in terms of filter reduction of particulates (sediment and TP) (Fig. 4 and 5). Dissolved phosphorus was found different at this site (Fig. 6), especially at B13. This large difference is likely related to the data gaps for these plots due to maintenance and equipment malfunction. It is expected that the data collected through the end of summer 2008 (rainy period) will match the trends observed in the previous study.

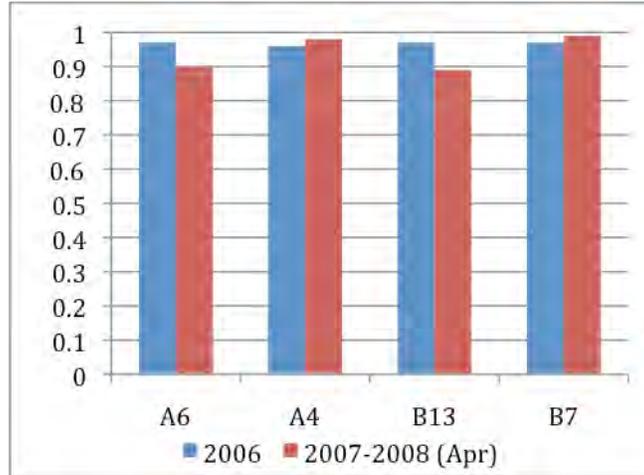
**Figure 5. Total Phosphorus removal efficiency of VFS during the period 2006 – 2008 (April).**

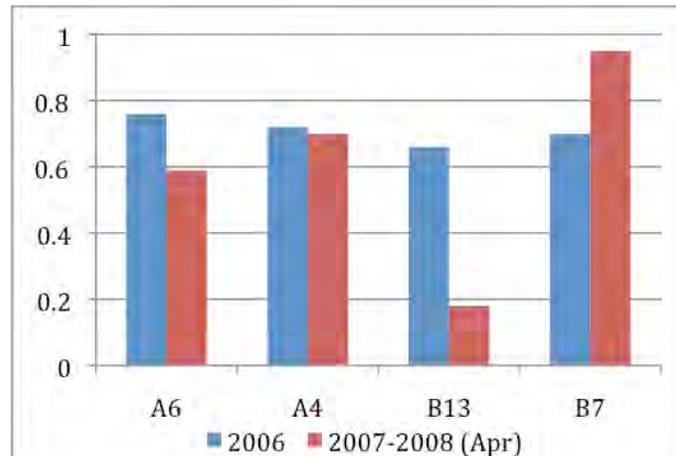
**Figure 6. Dissolved Phosphorus removal efficiency of VFS during the period 2006 – 2008 (April).**
