Final Project Report

FIELD AND DATA MAINTENANCE OF THE FL-DEP BoMR VEGETATIVE FILTER STRIP RESEARCH FACILITY IN HOMELAND, BARTOW (FL)

Sponsoring Agency:
The Florida Department of Environmental Protection
Bureau of Mine Reclamation
DEP Order No. 798181

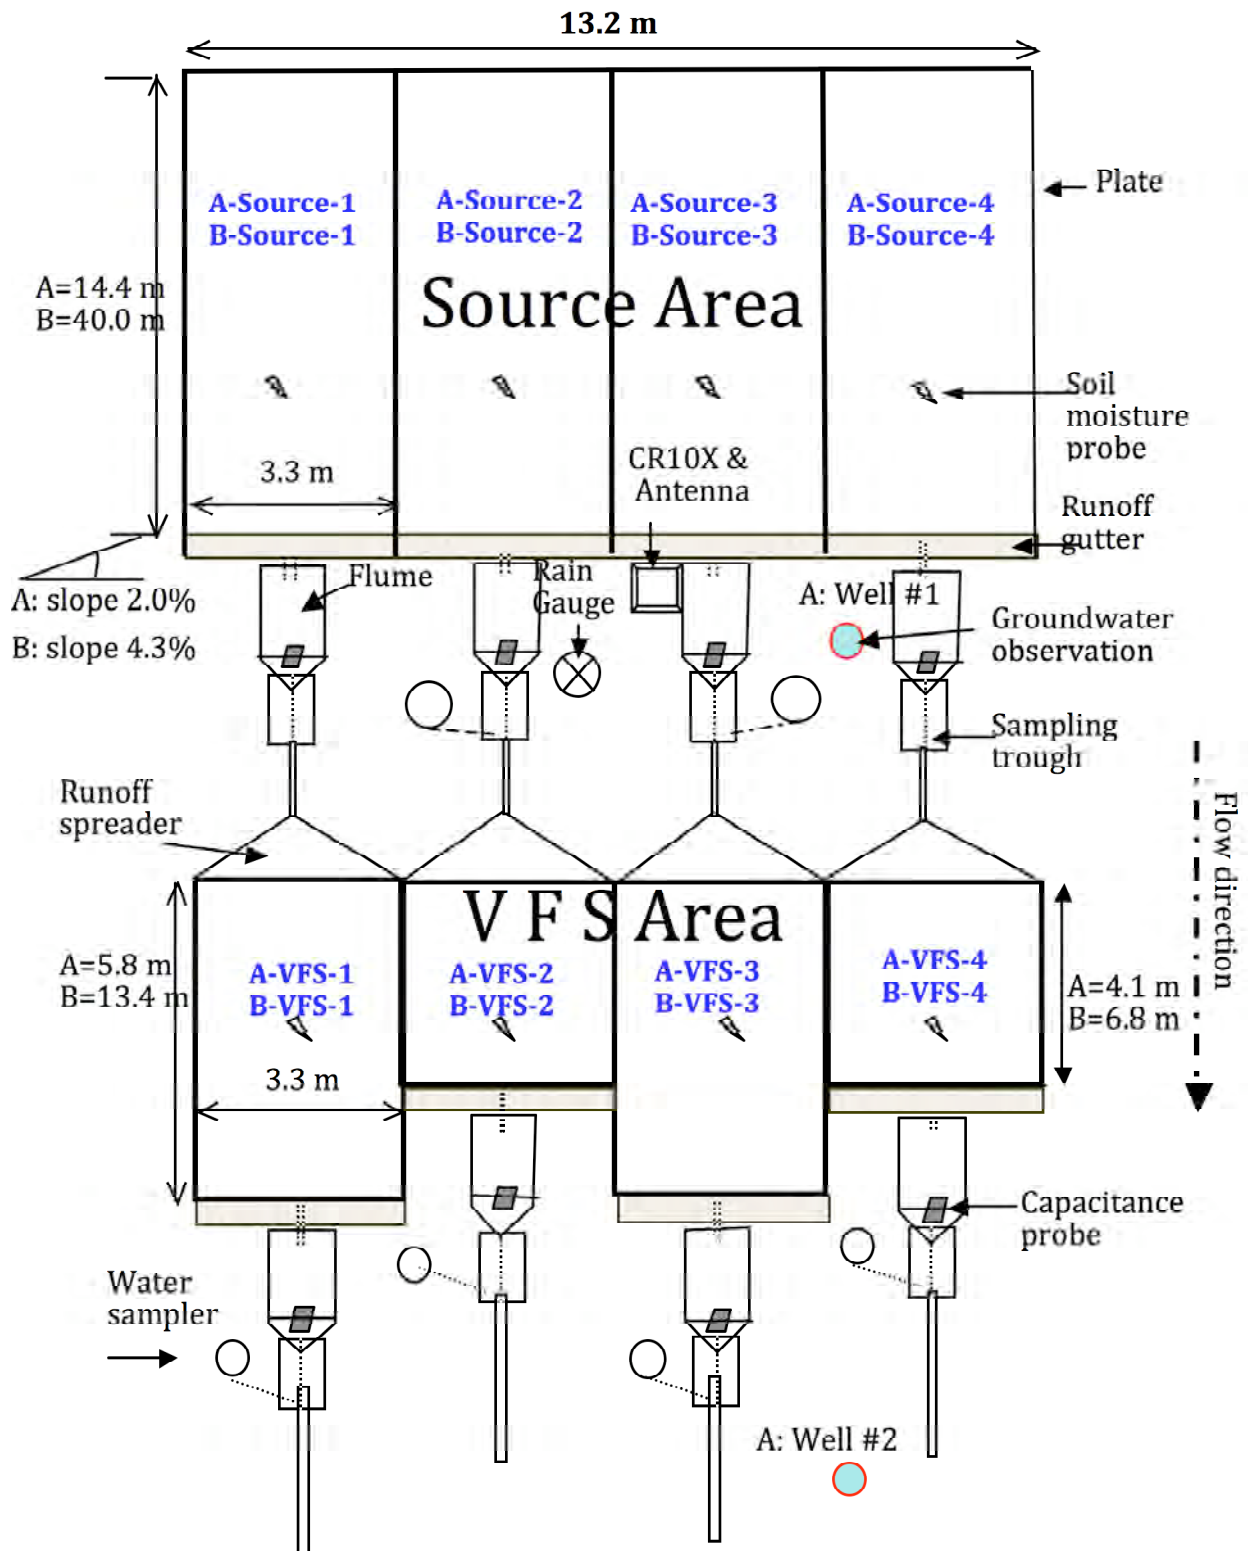
Figure 1. Schematic diagram of the experimental sites A (River) and B (Hill) in the Homeland Field Office, FL

To answer these questions, two experimental sites (A and B) containing 16 runoff plots (8 source+8 VFS) were selected and instrumented for this study (Fig. 1).

The sites represent the range of conditions commonly found in source areas (sand tailings) at the region (i.e. slopes of 2-4.5%, slope lengths of 14-40 m, vegetation properties, and soil hydraulic properties). Source areas were maintained bare (no vegetation) to represent the

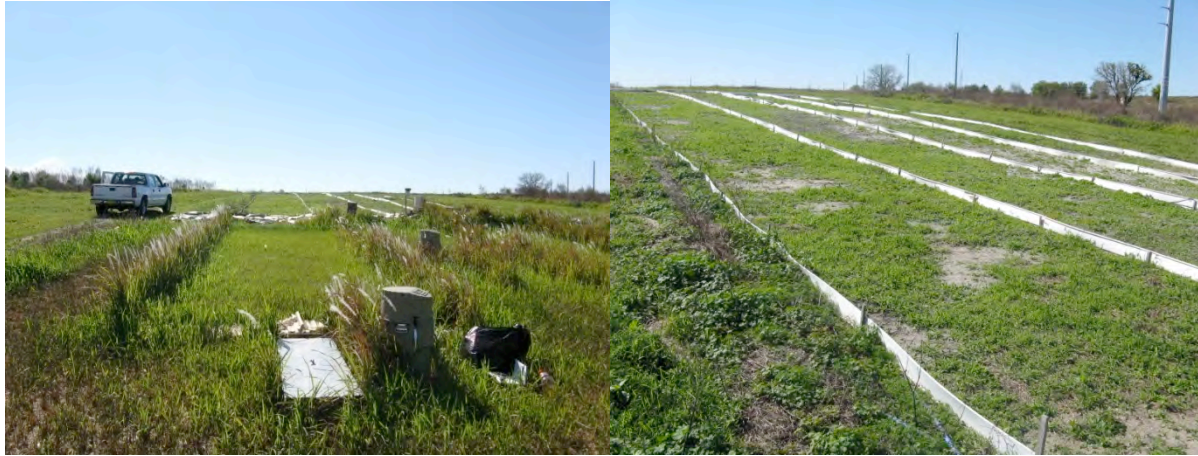
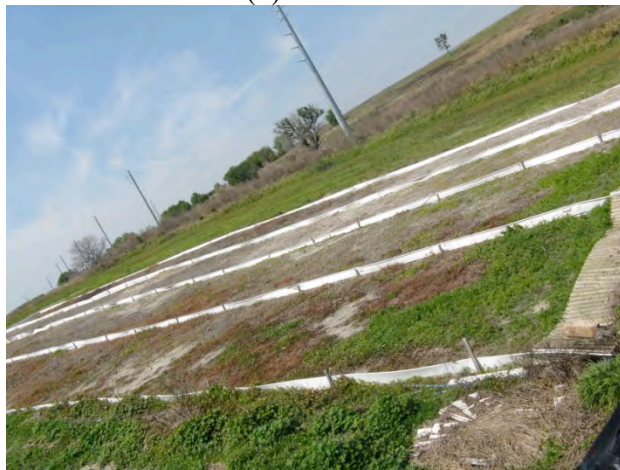
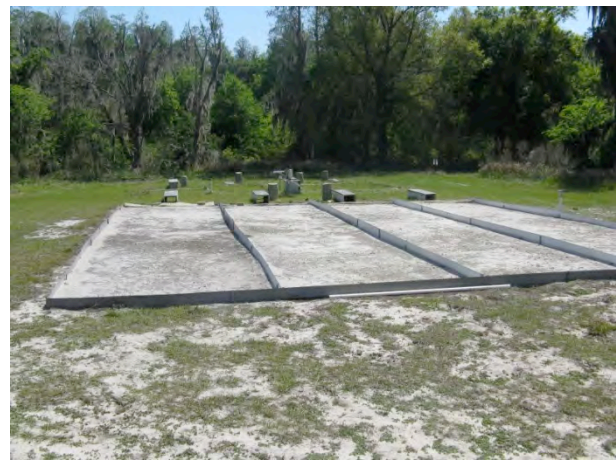
Figure 2. (a) & (b) Source area and VFS at hill on Feb 28 (2008), (c) Source area on March 13 (2008) at the Hill Site, and (d) source area at the River Site at any time of the year.

To ensure the worst-case scenario conditions the source areas were designed to be maintained bare (no vegetation at all times). Figure 2 shows the fast growth of weeds experienced at the Hill site. For instance, Hand removal of weeds and spot application of contact herbicide was done during the last week of January (2008). After a month, the source areas were completely covered again (Fig. 2a and 2b). Additional weed control took place the first week of March. By the second week of March the weeds were controlled, except for a small spot at the end of the source areas (Figure 2c). In contrast, Figure 2d shows that the source area on the River Site remained clean during all the year after receiving the same maintenance as in the Hill site.

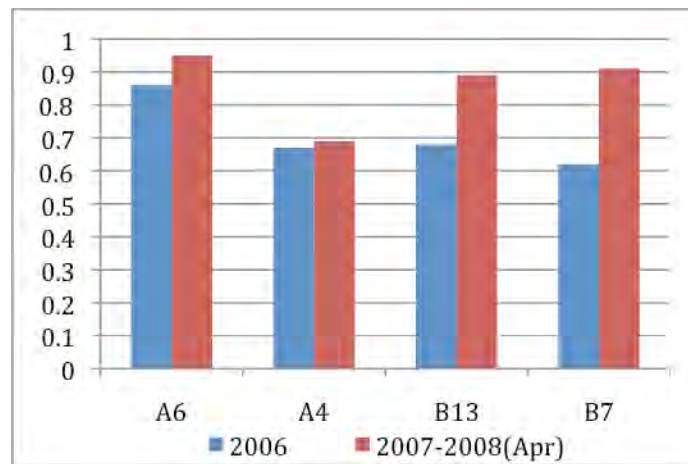
Figure 3. Flow volume removal efficiency of VFS during the period 2006 – 2008 (April)

For Site A (River) the filter efficiencies obtained in this report closely match and confirm those obtained in the previous 2006 study (Muñoz-Carpena et al., 2007). VFS runoff volume reduction efficiencies reported for plots A6 and A4 were similar, 0.86 and 0.67 respectively (Fig. 3). Sediment and TP removal for both studies were also close, above 0.9 (Fig. 4 and 5), and DP removal efficiencies were also lower than 0.70 in both studies although somewhat lower for plot A6 (Fig. 6). In general, filter length in general shows a clear trend in terms of reduction of runoff volume. This is clearly seen in Site A (Fig.3), with increased efficiencies for the longer filters.

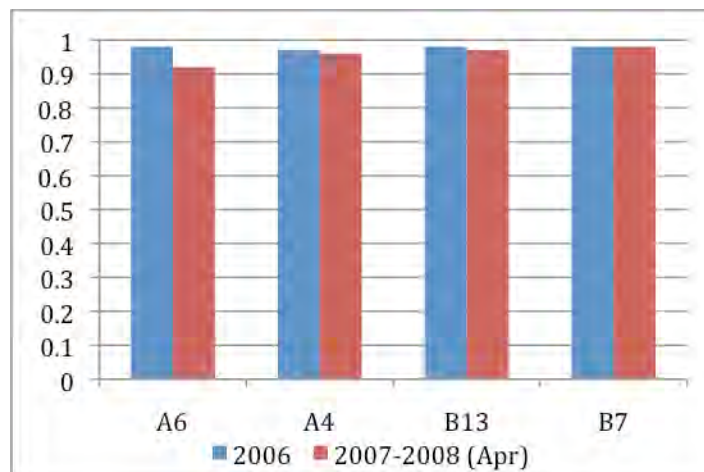
Figure 4. Sediment removal efficiency of VFS during the period 2006 – 2008 (April).

Results for the Hill B (River) were also similar between the two studies in terms of filter reduction of particulates (sediment and TP) (Fig. 4 and 5). Dissolved phosphorus was found different at this site (Fig. 6), especially at B13. This large difference is likely related to the data gaps for these plots due to maintenance and equipment malfunction. It is expected that the data collected through the end of summer 2008 (rainy period) will match the trends observed in the previous study.

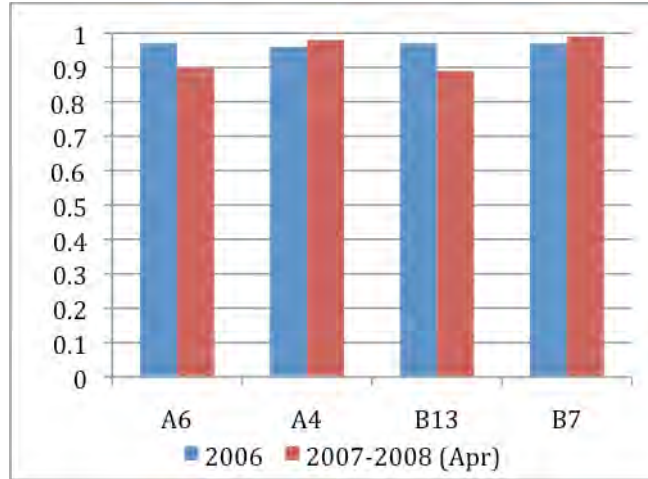
Figure 5. Total Phosphorus removal efficiency of VFS during the period 2006 – 2008 (April).

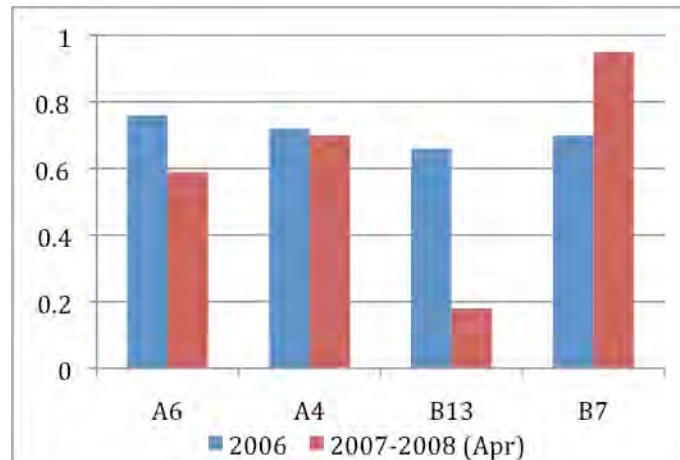
Figure 6. Dissolved Phosphorus removal efficiency of VFS during the period 2006 – 2008 (April).
